**REPORT**  
**ON**  
**THE ENGINEERING GEOLOGICAL INVESTIGATION**  
**ON**  
**PORTION 243**  
**OF**  
**THE FARM**  
**KNOPPIESLAAGTE 385 JR**  
**FOR**  
**TOWNSHIP ESTABLISHMENT**

APRIL 2013

PLAN ASSOCIATES

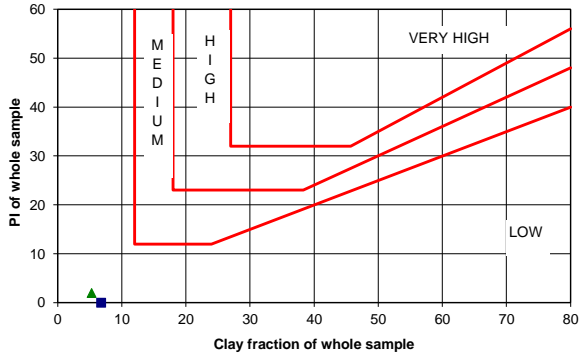
## POTENTIAL EXPANSIVENESS

Sample No.	KL1	KL2
Soillab sample no.	S13-0206-1	S13-0206-2
Depth (m)		
Position		
Material Description	LIGHT GREY FERRICRETE+QUARTZ  GRAVELLY SAND	DARK R BROWN FERRICRETE+QUARTZ  SANDY GRAVEL
Moisture (%)		
Dispersion (%)		
<b>SCREEN ANALYSIS ( % PASSING) (TMH 1 A1(a) &amp; A5)</b>		
63.0 mm	100	100
53.0 mm	100	100
37.5 mm	100	100
26.5 mm	100	100
19.0 mm	100	100
13.2 mm	97	93
4.75 mm	77	70
2.00 mm	64	53
0.425 mm	42	33
0.075 mm	20	17
<b>HYDROMETER ANALYSIS ( % PASSING) (TMH 1 A6)</b>		
0.040 mm	14	13
0.027 mm	13	11
0.013 mm	11	9
0.005 mm	8	7
0.002 mm	7	5
% Clay	7	5
% Silt	11	10
% Sand	46	37
% Gravel	36	47
<b>ATTERBERG LIMITS (TMH 1 A2 - A4)</b>		
Liquid Limit		20
Plasticity Index	SP	6
Linear Shrinkage (%)	1.0	3.0
Grading Modulus	1.74	1.97
Uniformity coefficient	173	152
Coefficient of curvature	2.0	1.7
Classification	A-1-b (0)	A-1-b (0)
Unified Classification	SM	SM & SC
Chart Reference

Assuming the laboratory test results typify the material encountered on the site, the application of the method of Van der Merwe shows that all the materials classify as “Low” and are therefore considered to be non-expansive.

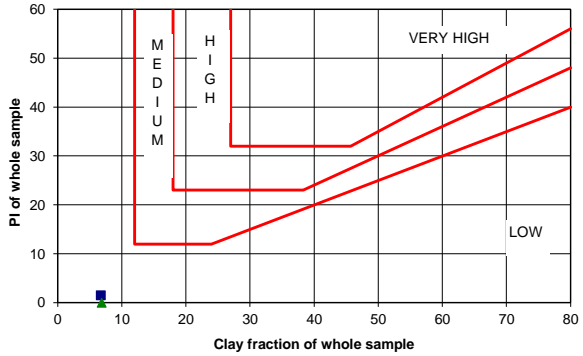
## POTENTIAL EXPANSIVENESS

Sample No.	KL3	KL4
Soillab sample no.	S13-0206-3	S13-0206-4
Depth (m)		
Position		
Material Description	DARK BROWN FERRICRETE+QUARTZ  SANDY GRAVEL	DARK BROWN FERRICRETE+QUARTZ  GRAVELLY SAND
Moisture (%)		
Dispersion (%)		
<b>SCREEN ANALYSIS ( % PASSING) (TMH 1 A1(a) &amp; A5)</b>		
63.0 mm	100	100
53.0 mm	100	100
37.5 mm	100	100
26.5 mm	100	100
19.0 mm	100	100
13.2 mm	94	94
4.75 mm	68	77
2.00 mm	57	69
0.425 mm	37	43
0.075 mm	18	17
<b>HYDROMETER ANALYSIS ( % PASSING) (TMH 1 A6)</b>		
0.040 mm	14	14
0.027 mm	13	12
0.013 mm	10	10
0.005 mm	8	9
0.002 mm	7	7
% Clay	7	7
% Silt	9	9
% Sand	41	53
% Gravel	43	31
<b>ATTERBERG LIMITS (TMH 1 A2 - A4)</b>		
Liquid Limit	17	
Plasticity Index	4	SP
Linear Shrinkage (%)	2.0	1.0
Grading Modulus	1.88	1.72
Uniformity coefficient	186	106
Coefficient of curvature	1.4	2.5
Classification	A-1-b (0)	A-1-b (0)
Unified Classification	SM & SC	SM
Chart Reference

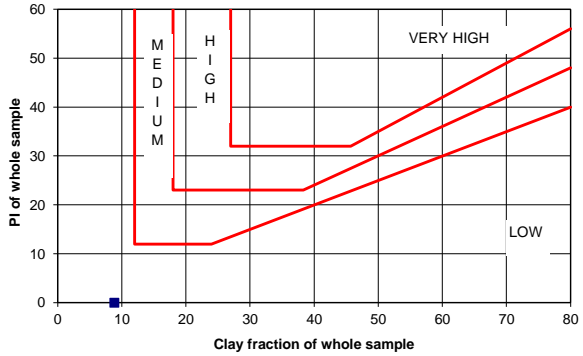
## POTENTIAL EXPANSIVENESS

Sample No.	KL5	
Soillab sample no.	S13-0206-5	
Depth (m)		
Position		
Material Description	DARK BROWN QUARTZ  GRAVELLY SAND	
Moisture (%)		
Dispersion (%)		
<b>SCREEN ANALYSIS ( % PASSING) (TMH 1 A1(a) &amp; A5)</b>		
63.0 mm	100	
53.0 mm	100	
37.5 mm	100	
26.5 mm	100	
19.0 mm	100	
13.2 mm	99	
4.75 mm	97	
2.00 mm	86	
0.425 mm	55	
0.075 mm	23	
<b>HYDROMETER ANALYSIS ( % PASSING) (TMH 1 A6)</b>		
0.040 mm	19	
0.027 mm	17	
0.013 mm	13	
0.005 mm	11	
0.002 mm	9	
% Clay	9	
% Silt	12	
% Sand	65	
% Gravel	14	
<b>ATTERBERG LIMITS (TMH 1 A2 - A4)</b>		
Liquid Limit		
Plasticity Index	SP	
Linear Shrinkage (%)	1.0	
Grading Modulus	1.36	
Uniformity coefficient	167	
Coefficient of curvature	7.0	
Classification	A-2-5 (0)	
Unified Classification	SM	
Chart Reference
